Generating a 3D Tool to Represent Graphically the Damages of Santa Barbara Castle (Alicante)

Víctor Echarri, A. B. González Avilés, J. Garabito, M. I. Pérez Millán, A. Priego

Department of Building Constructions, University of Alicante, University of Burgos, Spain

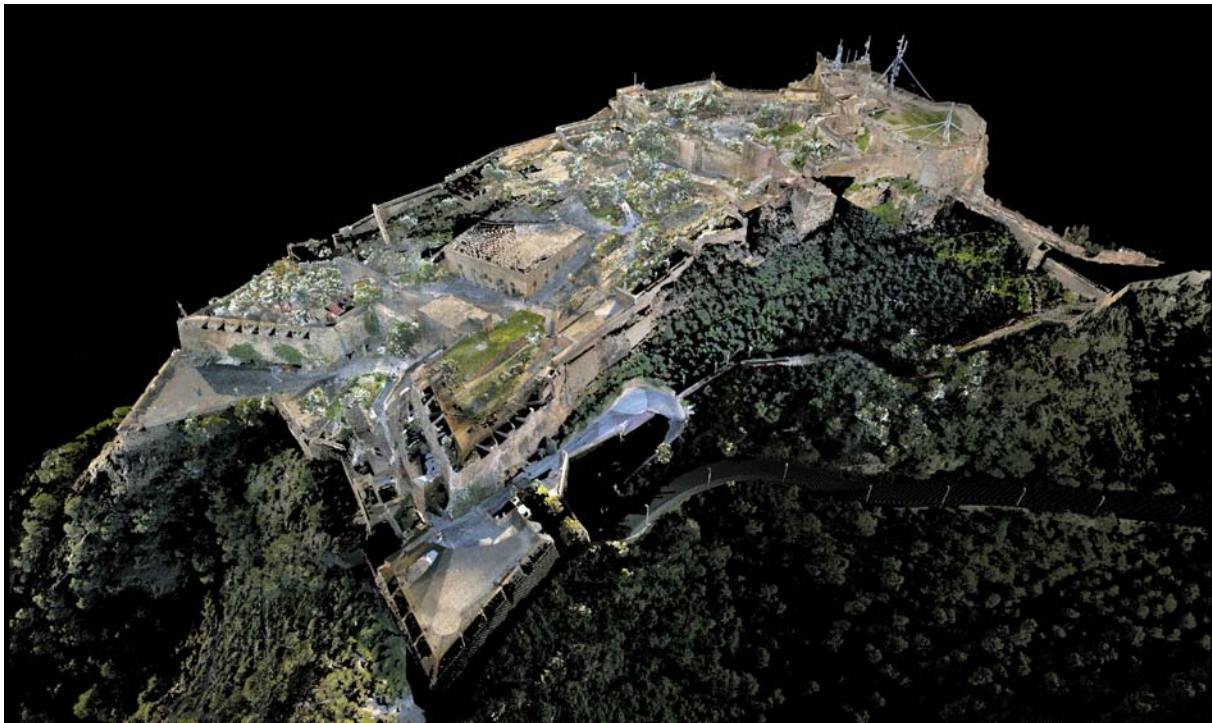
Fig. 1 3D view of the object, Santa Barbara Castle, Alicante.

different shots, getting a 3D object consisting of a point cloud. It is possible to incorporate color to this object, with the limitations of light that incises in each one of the shots, and taking into account that initially it does not apply color to the interstices between points (Fig. 1). The light conditions vary greatly during the scanning process when working outside.

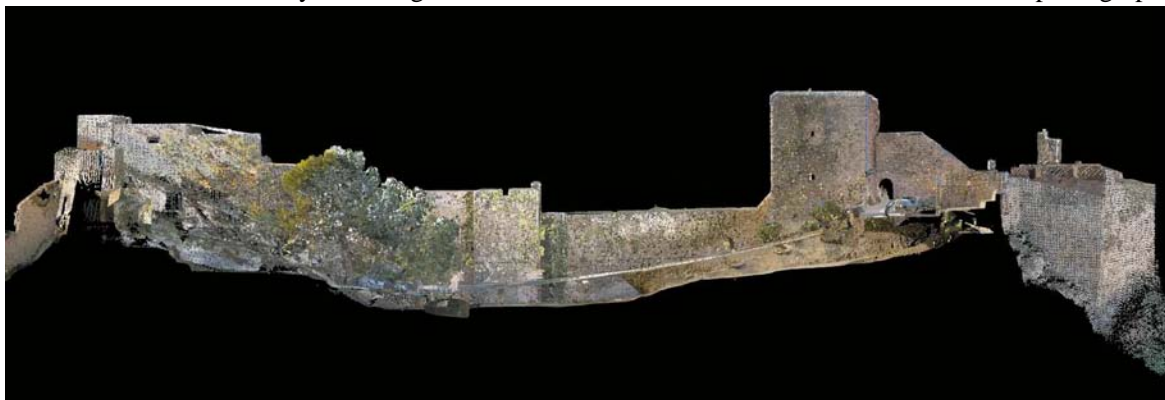
Fig. 2 Front elevation of the castle with the Santa Catalina tower, Muslim style.

Pro to generate plans and general elevations, and plans and elevations of details of the various buildings and architectural elements of the castle (Fig. 2).
